# Fire in the Cockpit: The Apollo 1 Tragedy

Leadership ViTS Meeting  
February 2008

Bryan O' Connor  
Chief, Safety and Mission Assurance

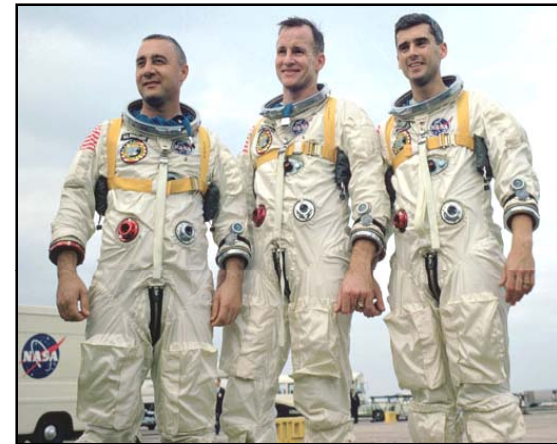
Grissom, White and Chaffee.
